BLUE GIANT MEADOW DAM

NDI ID ~~NO~~ - PA-00564
DER ID ~~NO~~ - 40-80

**PHASE I INSPECTION REPORT
NATIONAL DAM INSPECTION PROGRAM**

APRIL 1981

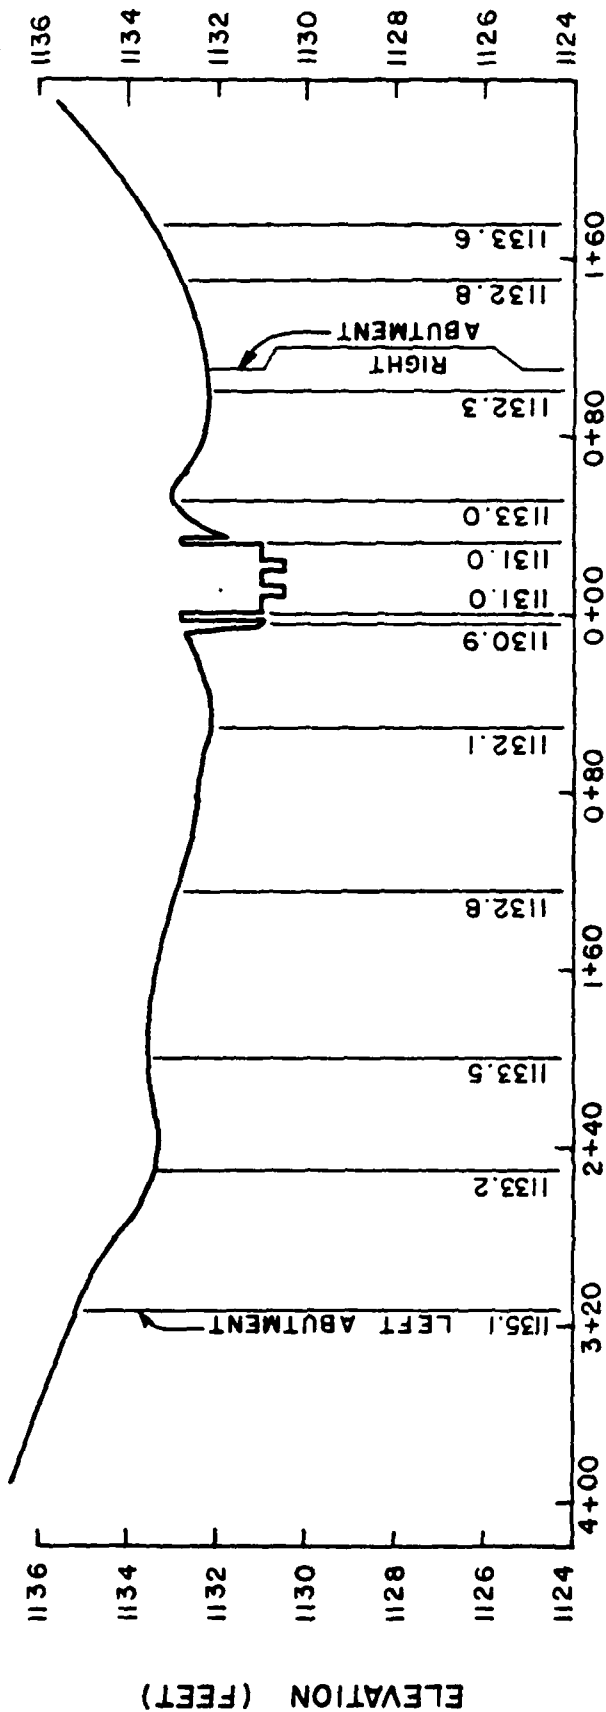
TOP OF DAM - PROFILE

b. Embankment. The entire embankment is overgrown with brush and trees, which made inspection difficult. The 9 foot wide crest is irregular with low spots occurring adjacent to the spillway and then generally rising toward the abutments. The apparent cause of the low spots is erosion by flood flows passing behind the spillway walls. This flow is also eroding the adjacent downstream slope. The upstream slope is 1V:1H for two feet below the crest, then 1V:2.5H for a horizontal distance of approximately three feet before steepening to 1V:1.4H below the water line. The downstream face is also irregular and slopes 1V:12H for the first fifteen feet and then 1V:1.5H. These irregular slopes are apparently the result of the random placement of additional earth over the original dam, rather than indications of any instability. However two large voids were found during the review inspection near the toe, just left of spillway. These voids could be probed to a depth of five feet. There is no riprap on the upstream face but erosion does not appear to be a problem except adjacent to the spillway. Approximately one gallon per minute of clear seepage was noted downstream of the right side of the spillway. The source may be the original sluiceway through the dam but rocks totally obscured the assumed location of the outlet. It should be noted that during the review inspection flow over the spillway prevented a check of this seepage. The dam is reported to contain a concrete corewall, the top of which is visible at the low spot behind the left spillway wall.
